CONTRA COSTA COUNTY

SANITARY DISTRICT No. 6

System Evaluation and
Recommended Improvements Report

January 22, 2014

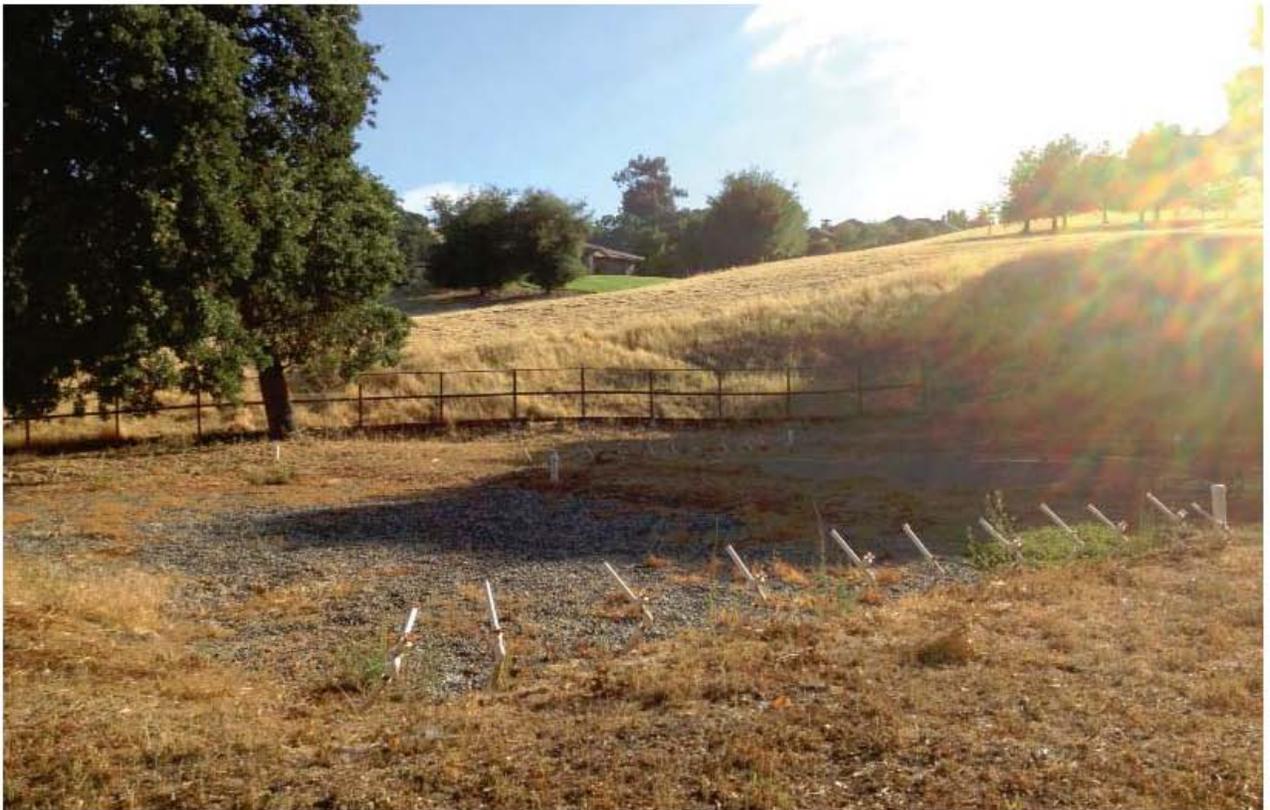
Filter #1 (the one closest to the hill, farthest from the stream) is out of operation due to control problems. As discussed below, the controls probably should be replaced with a small programmable logic controller (PLC).

Groundwater also enters Filter #1 or both filters during wet weather. During very wet periods, Filter #1 has been observed to be full of water even when the recirculation pumps are turned off and the recirculation tank is full. Under these conditions, water drains from the filter directly to the UV pump wet well and there should be no water in the filter. The filter is kept full because groundwater is entering it.

Recirculating gravel filter bed

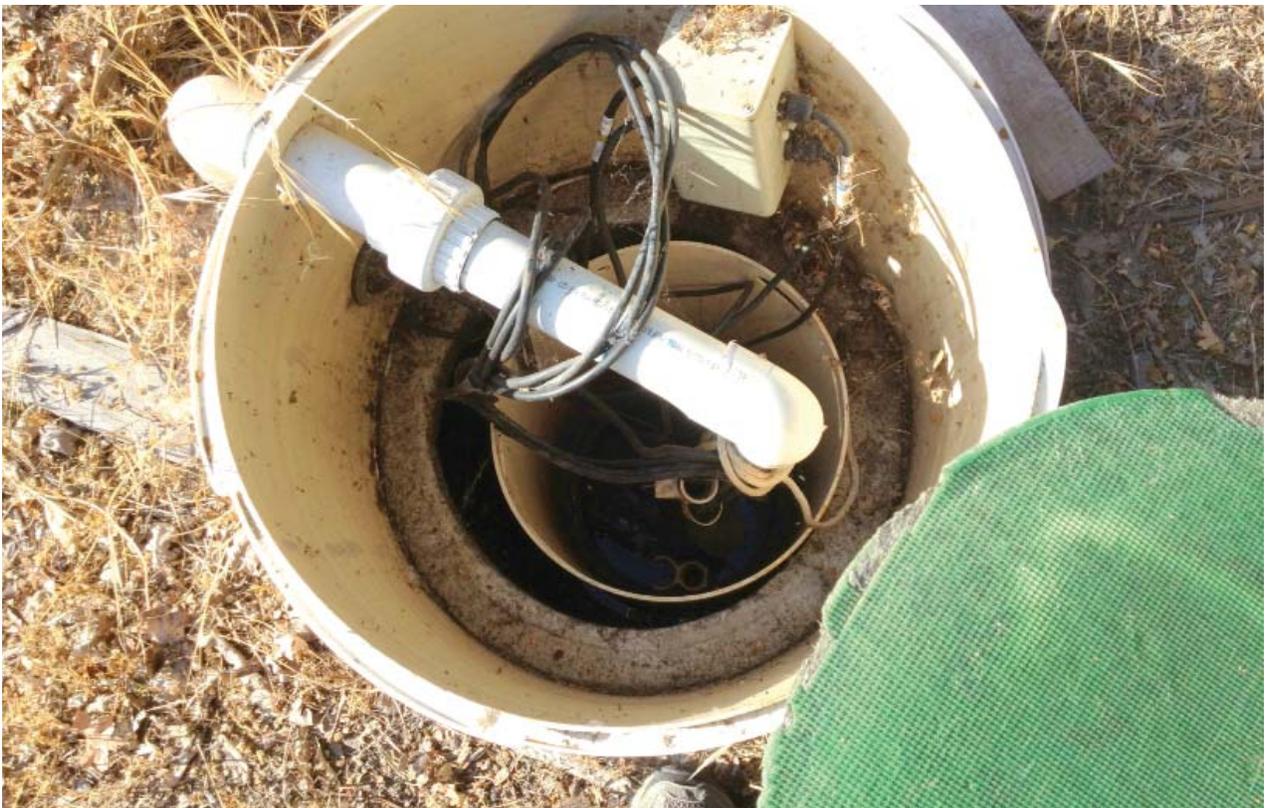
The original treatment plant design calls for three recirculation pumps for each filter, a total of six recirculation pumps. Four of the six recirculation pumps are inoperable. The two operable pumps are used with Filter #2. As noted below, Filter #1 is out of operation.

Recirculation pump

All inoperable pumps should be replaced with new pumps. It is recommended that replacements also be purchased for the two operable pumps since they have been in service for a long time.

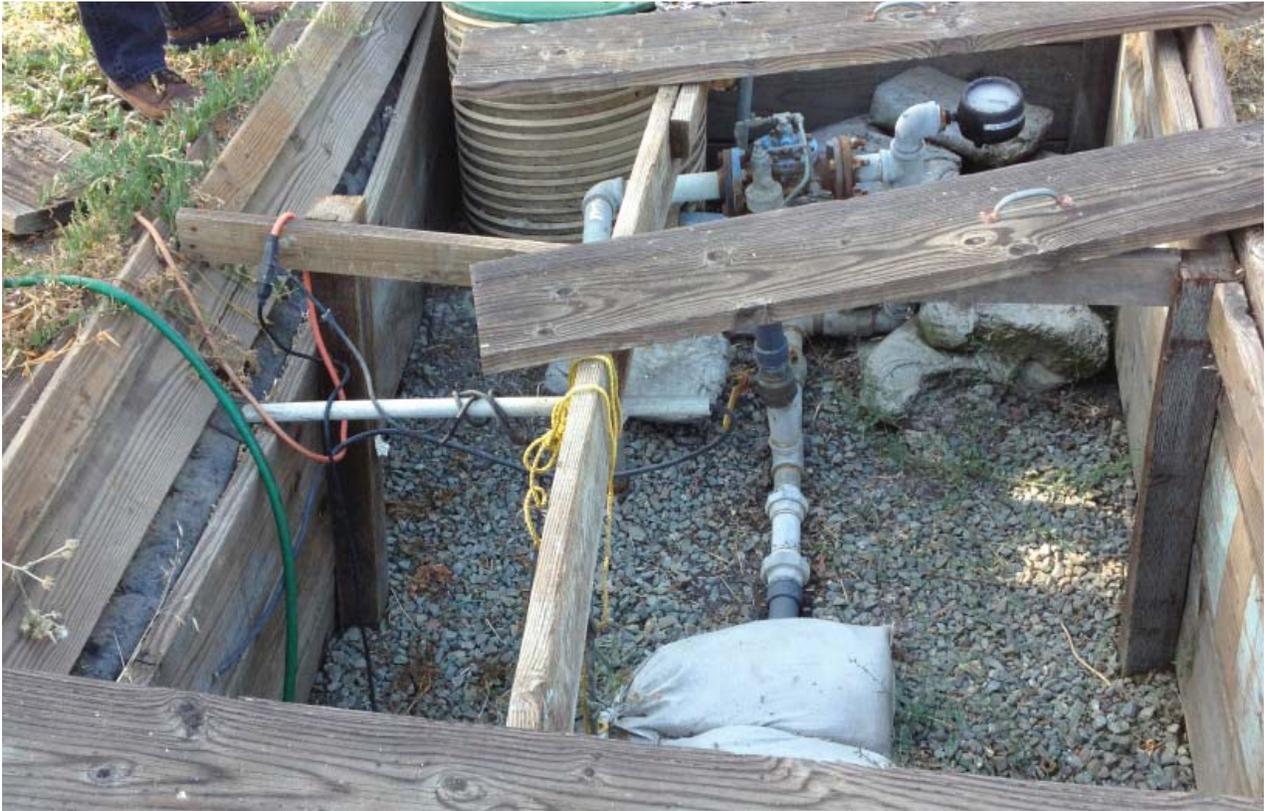
The 5 horsepower (HP) effluent pumps are the largest pumps in the system. They are high head turbine pumps and have failed several times in the past. The existing effluent pumps have been in service since March, 2013 and December, 2012, and are currently in satisfactory condition.

Failure of these pumps can cause a spill. In the past, to avoid a spill wastewater has been trucked away for extended periods at considerable expense. Ernie's was paid \$11,615 for trucking wastewater away in December, 2012 alone. This expense would have been avoided in part or in whole if a spare effluent pump had been on hand.

Effluent pump station vault

Due to the risk of a spill if the effluent pumps fail and the high cost of hauling wastewater when these pumps are not available for service, a spare pump should be purchased.

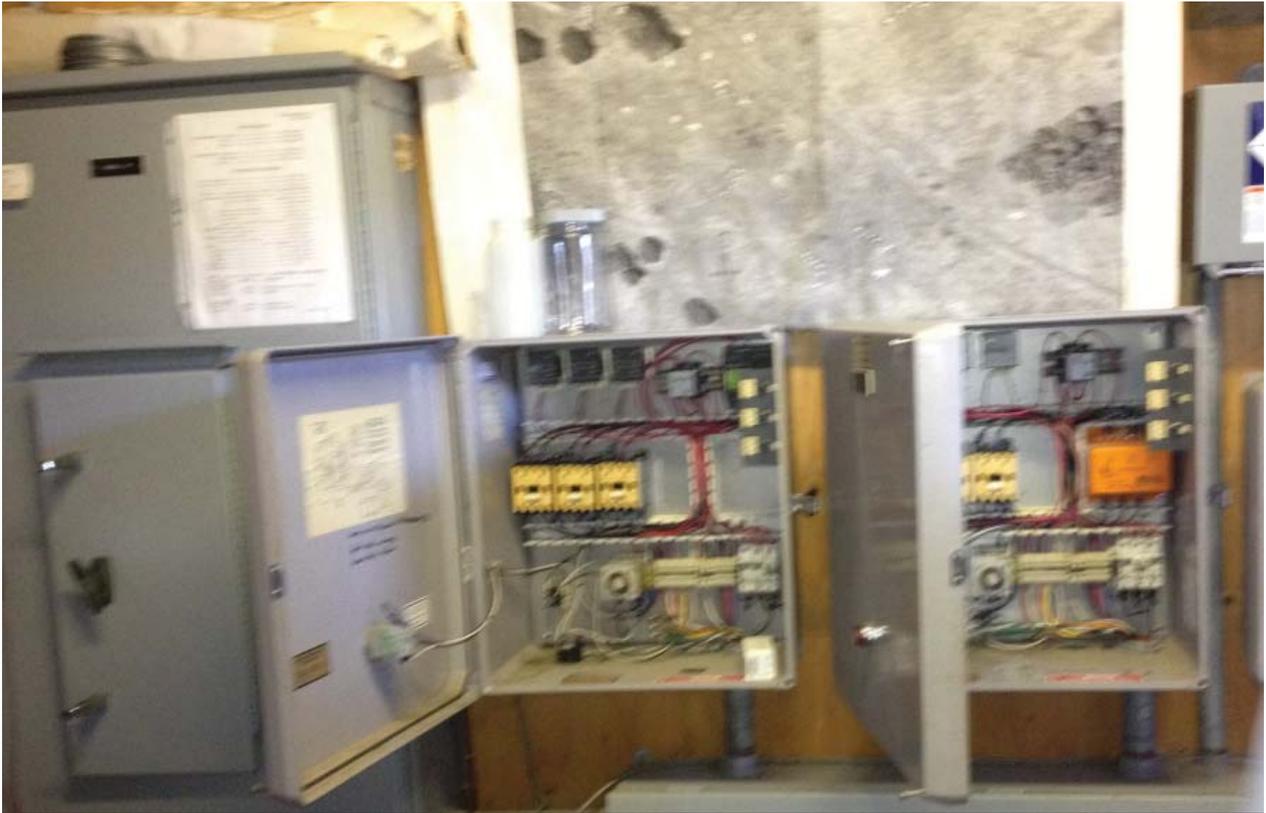
The control system relies on electrical relays. The control equipment is old and frequently malfunctions. There is a considerable risk of failure that might cause a spill. The best course of action probably is to replace the control system with a computer based system, i.e. with a PLC. Such a system would allow much greater flexibility in operations and data gathering, would be more reliable, and would mesh well with improvements in the alarm system.

Control panel and alarm system

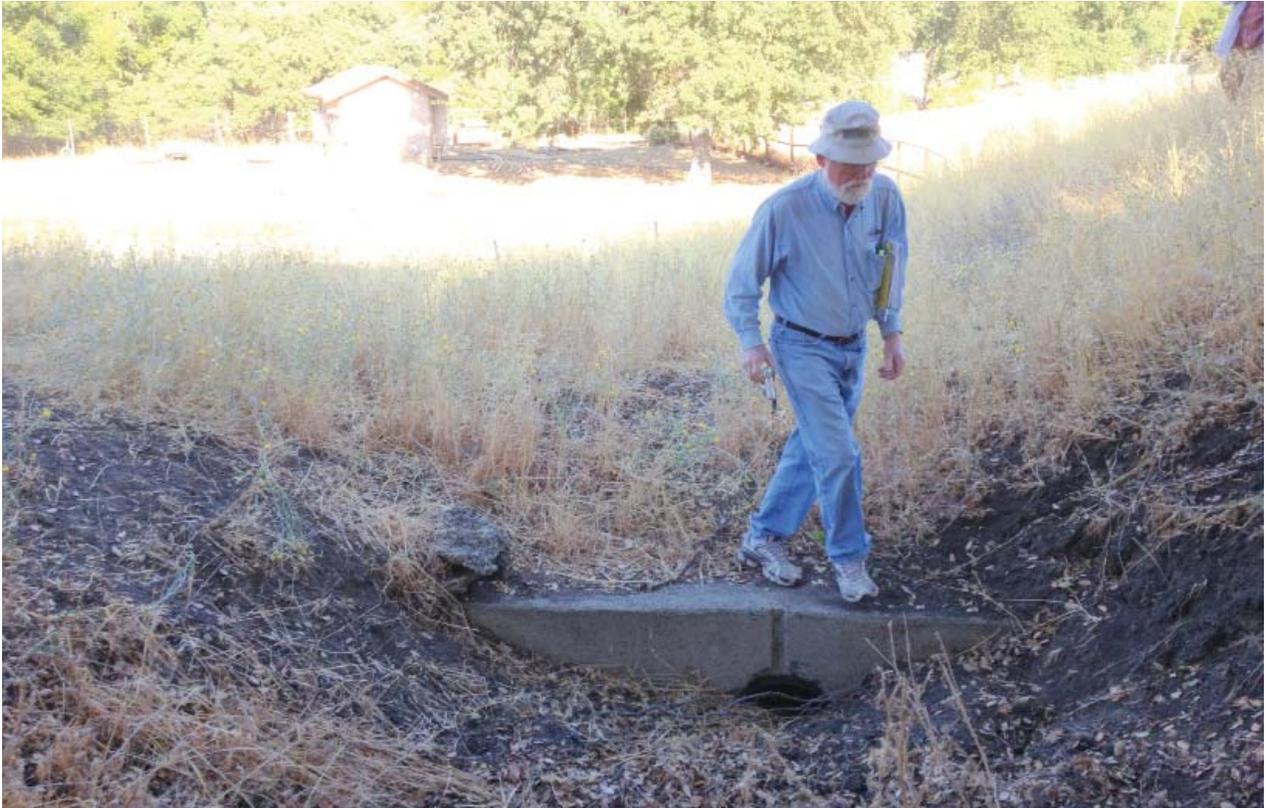
These problems are not completely understood. There is a headwall with an inlet to a 10-inch drainage pipe just uphill to the east of Filter #1. Brush and sediment accumulate at the inlet of the drainage pipe from the hillside above, which causes stormwater to overflow the headwall and enter Filter #1.

Deficient storm drain pipe above filter #1

It might be possible to avoid the surface runoff problem by maintaining the inlet to the 10" culvert above the treatment plant to keep it clear of debris and sediment; however the hydraulic capacity of the drainage pipe may be inadequate. The drainage pipe is not shown on the construction drawings and the location of the outlet end of the pipe is unknown. The drainage pipe may have been added to the project during construction.
